57 Troubleshooting

This chapter provides information that will help you troubleshoot OmniSwitch and Omni Switch/Router hardware and software problems. The sections within this chapter describe problems or errors you may encounter during switch hardware and software installation, configuration, or operation. Subsections within these categories reflect unique problems and provide the recommended corrective action(s).

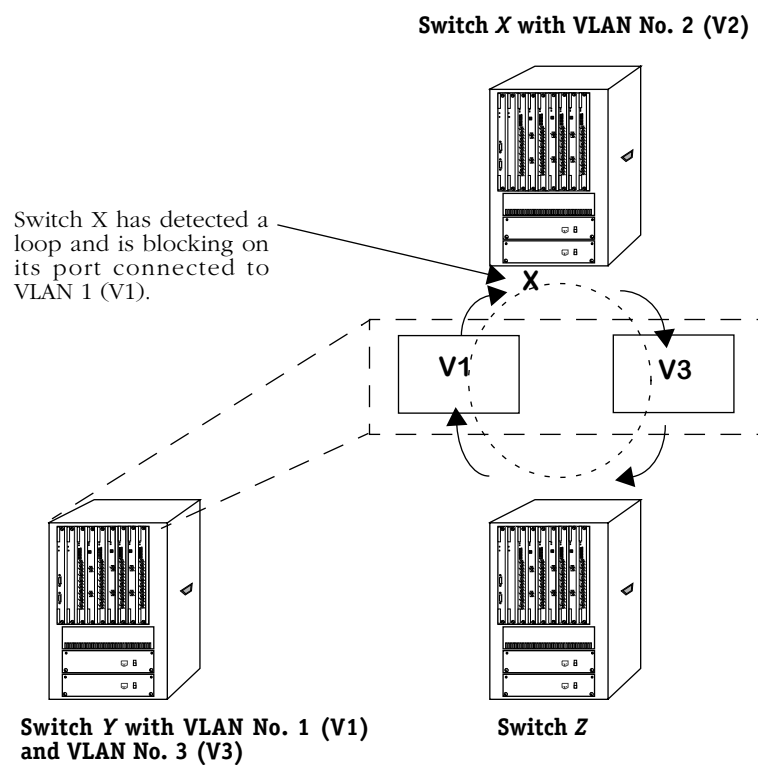
Deadlocked VLANs Due to Loop

If, for example, you have a setup with three switches, as shown in the following figure, the VLAN can enter a deadlock. In this example, there are two switches, one configured with one VLAN (Switch X), another configured with two VLANs (Switch Y), and another switching device that connects to the VLANs (Switch Z).

In this situation, VLAN 2 (V2) in the Switch X is in a loop because it has not learned that it has connected to Switch Y with two virtual bridges (V1 and V3), which are inside one switch. Since V2 detects a loop, it invokes blocking at the port connected to V1, which results in a deadlock. V1 and V3, inside Switch Y, can still communicate, and traffic still exits V2 in Switch X, going to V3; however, traffic will not exit V3.

Occasionally, a VLAN may deadlock. This may be a result of the configuration process you used when you set up the VLANs.
