39 Troubleshooting

This chapter provides information on troubleshooting OmniStack hardware and software.

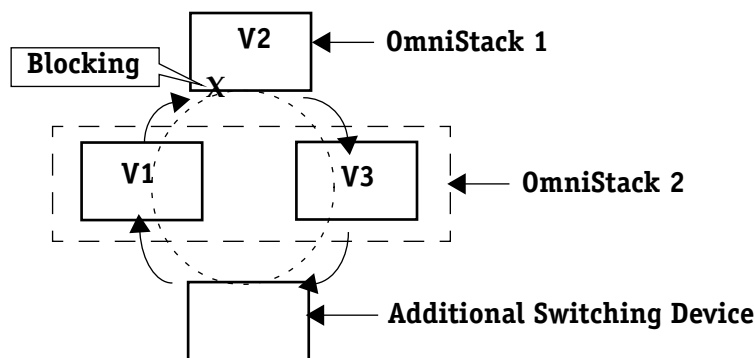
Deadlocked VLAN Example

In the example illustrated below, there are two OmniStack devices: OmniStack 1 (configured with one VLAN) and OmniStack 2 (configured with two VLANs). There is also an additional switching device that connects to the OmniStack 2 VLANs.

In this situation, V2 in OmniStack 1 is in a loop because it has not learned that it has connected to a device with two virtual bridges (i.e., V1 and V3) which are both located in OmniStack 2. Since V2 detects a loop, it invokes blocking on the port connected to V1, which results in a deadlock. V1 and V3, located in OmniStack 2, can still communicate and traffic still moves from V2 in OmniStack 1 to V3 in OmniStack 2. However, traffic will not exit V3.

If you have a setup with four boxes, like the following figure shows, the VLAN can enter a deadlock.
