32 Troubleshooting

This chapter provides information on troubleshooting OmniAccess 512 hardware and software.

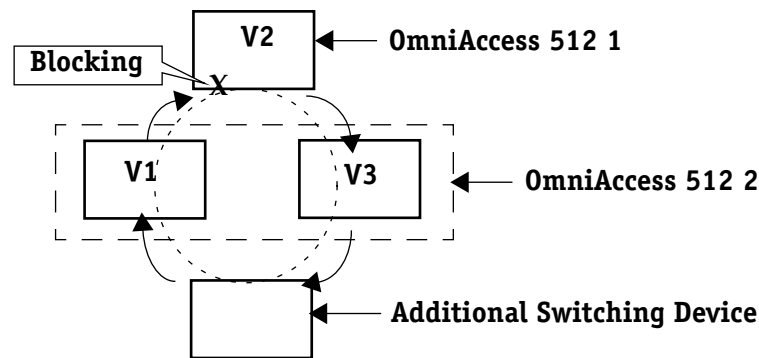
Deadlocked VLAN Example

If you have a setup with four boxes, like the following figure shows, the VLAN can enter a deadlock.

In the example illustrated below, there are two OmniAccess 512 devices: OmniAccess 512 1 (configured with one VLAN) and OmniAccess 512 2 (configured with two VLANs). There is also an additional switching device that connects to the OmniAccess 512 2 VLANs.

In this situation, V2 in OmniAccess 512 1 is in a loop because it has not learned that it has connected to a device with two virtual bridges (i.e., V1 and V3) which are both located in OmniAccess 512 2. Since V2 detects a loop, it invokes blocking on the port connected to V1, which results in a deadlock. V1 and V3, located in OmniAccess 512 2, can still communicate and traffic still moves from V2 in OmniAccess 512 1 to V3 in OmniAccess 512 2. However, traffic will not exit V3.
